Lightning and Surge Protection of Photovoltaic Installations

Two Case Histories: Vulcano and Kythnos

François D. Martzloff

June 1989

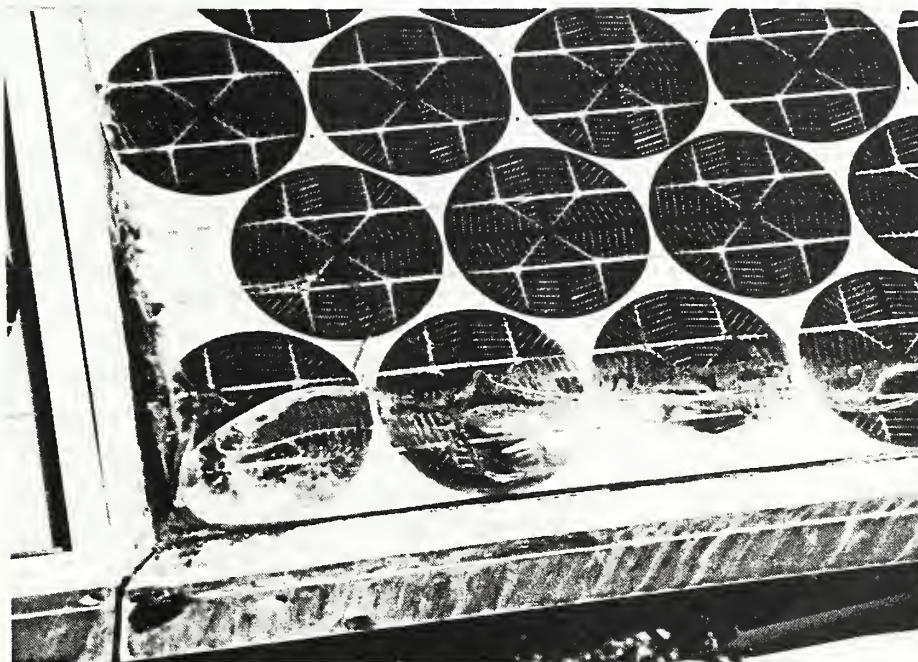
3-34 Detail of bottom left corner

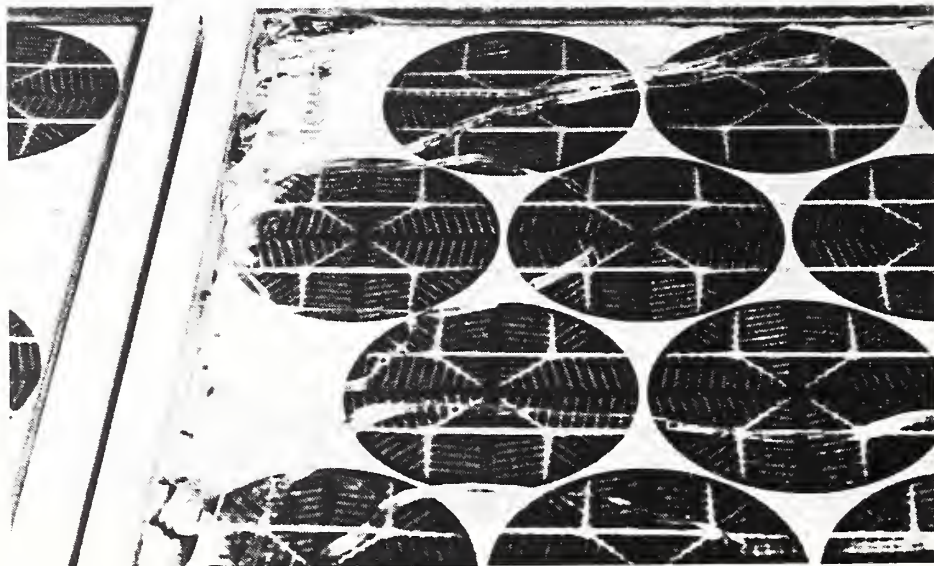
3-35 MODULE-310 0592 - Damage limited to left edge
